Foundation Inspection & Consulting

Inspection of Property: 317 N Bentwood Dr Rose Hill, Ks 67133

In re: Condition of Foundation Survey

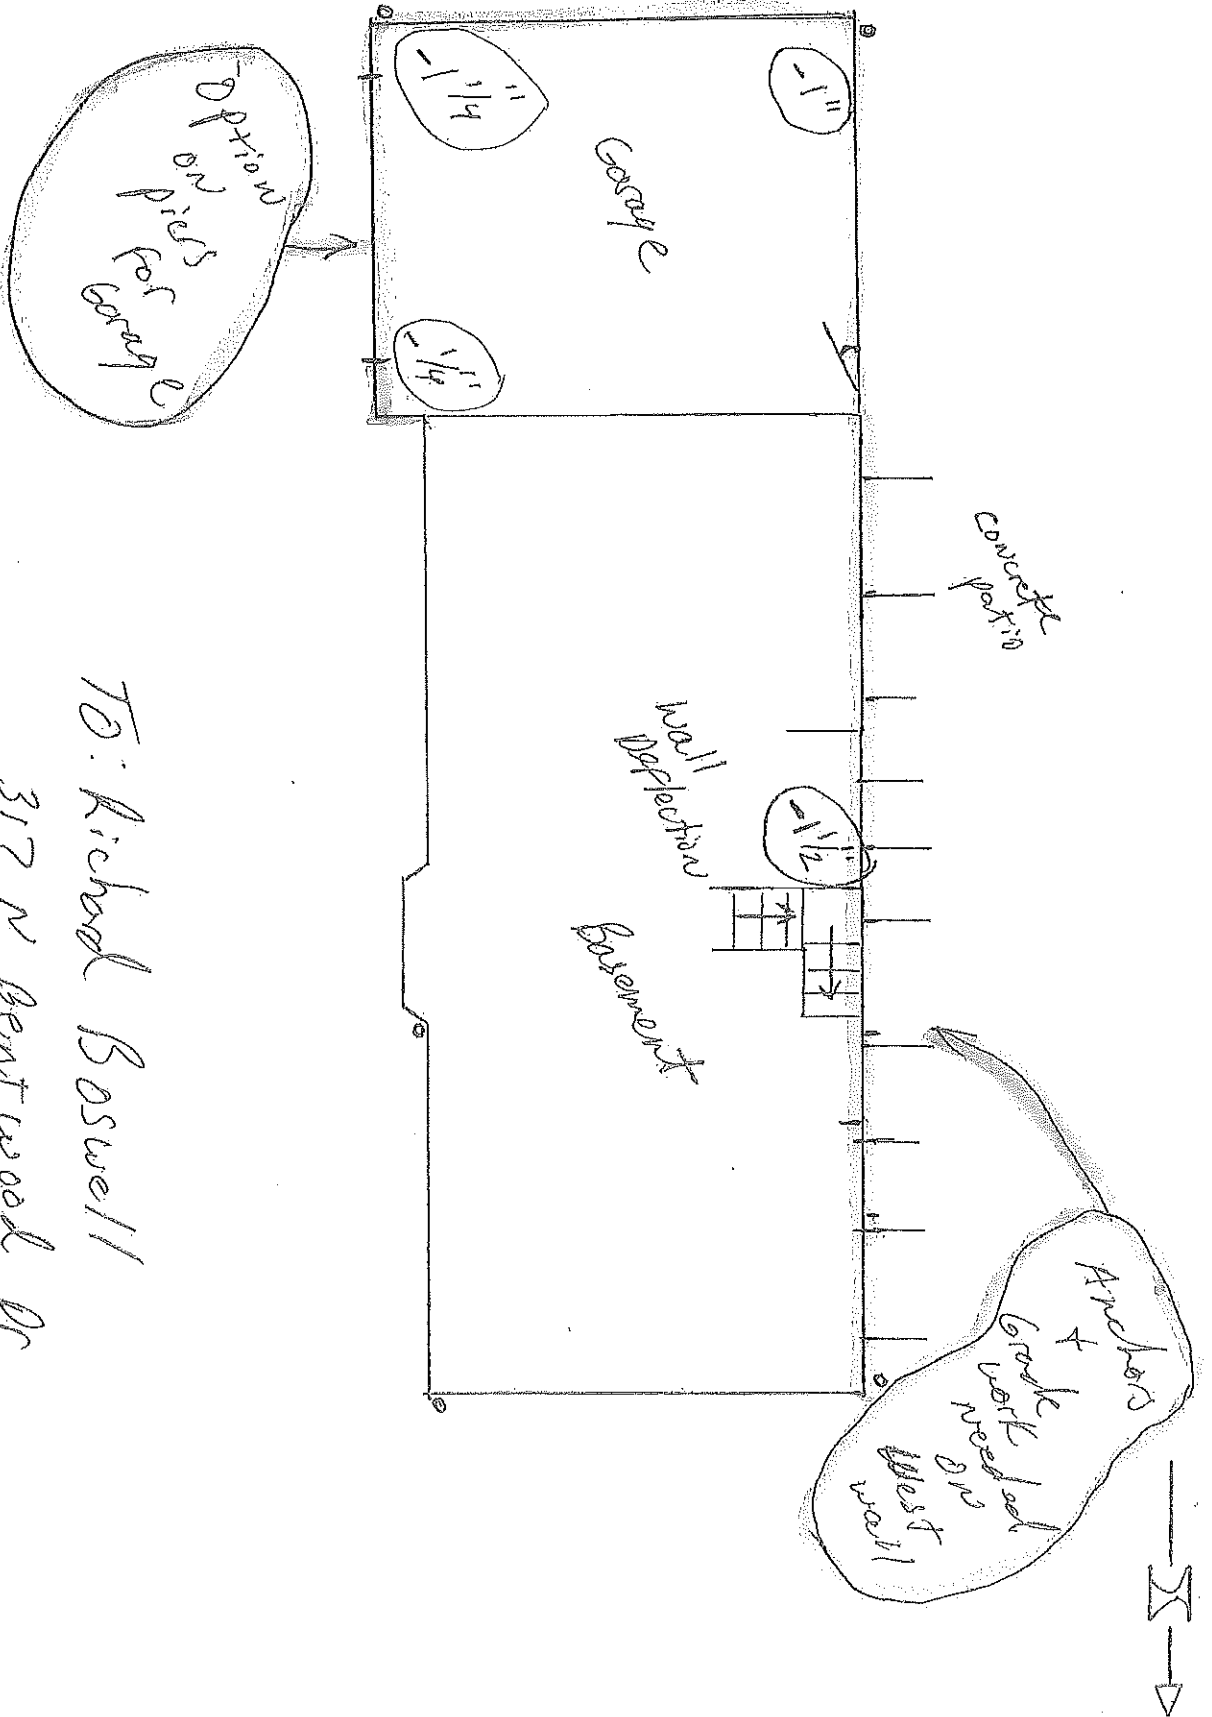
The West basement wall is 50' in length and shows 1-1/2" lateral movement. With the stair case the best repair for this wall would be an anchor system. This wall also is in need of grade and drainage change. Cost range for the wall anchors. \$5,500.00-\$7,500.00
Area marked in Green on drawing.

The garage foundation is at frost footing depth. Laser readings show 1" deviation in the SW corner 1-1/4" deviation in the SE corner and 1/4" deviation in the NE corner.

Note: To repair differential movement in the garage steel piers would be recommended. Cost range for this repair. \$14,400.00-\$21,600.00
Area marked in Pink on drawing.
