**LIMITED PRE-REMEDICATION INVESTIGATION
FOR INDOOR ENVIRONMENTAL QUALITY
OF**

LAKECREST BIBLE BAPTIST CHURCH
1709 SOCONY STREET
AUGUSTA, KANSAS 67010

RE: Limited Pre-remediation Indoor Environmental Quality (IEQ) investigation of Lakecrest Bible Baptist Church, 1709 Socony Street, Augusta, K

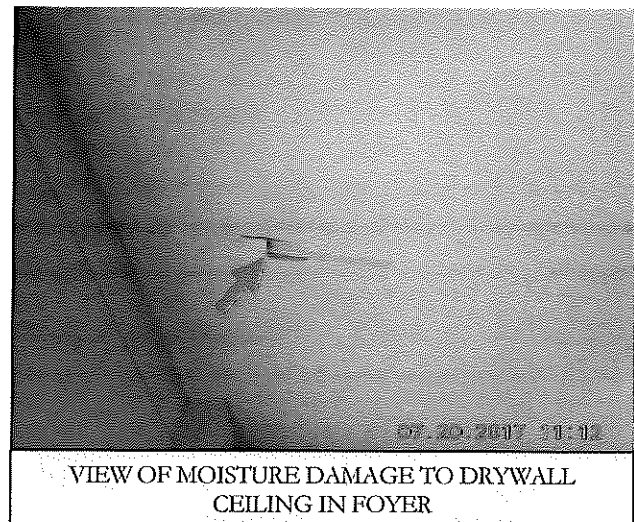
Main Level – Hallway/Foyer

- During the inspection of the foyer identified that the sheetrock/drywall ceiling to be affected with visible moisture damage from a past rook leak. The inspection identified the sheetrock/drywall no visible microbial/fungal growth.

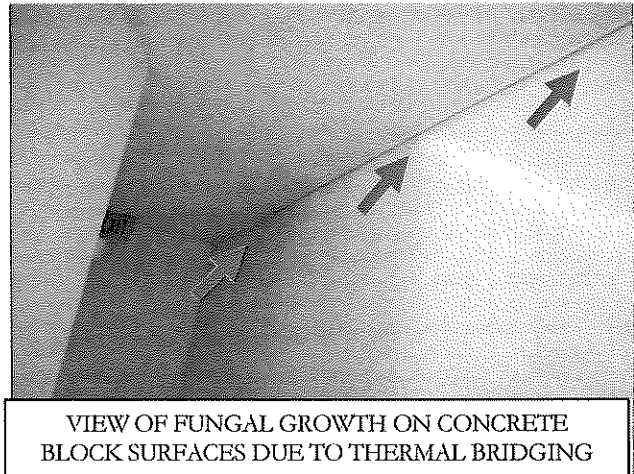
Stairwell – North Perimeter Wall

- During the inspection of the stairwell, it was observed that the painted concrete block wall near the ceiling is affected with minimal microbial/fungal growth.

- It is my belief that the microbial/fungal growth is the result of condensation due to a phenomenon called thermal bridging.
 - o Thermal bridges are weaknesses within a building's structure where heat and/or cold is transferred at a substantially higher rate than through the surrounding envelope area.

- Interior surface temperatures of the perimeter walls can drop well below the dew point. This leads to condensation, deteriorates plaster and paintwork and is an ideal condition for microbial/fungal growth. (Source - National Institute of Building Sciences)

Therefore, it is recommended and the most likely economical solution at this time, to control the microbial/fungal on the painted concrete block surfaces that maintenance be performed to include the periodic cleaning the affected concrete block surfaces.

Area:	Level:	Recommendations:
Stairwell	Small	While utilizing applicable recommended remediation procedures as detailed below in Section 8.0 , a containment is not necessary in order to facilitate the following: 1. Clean concrete block surfaces by wet wiping with a TSP, soap & water, or other approved detergent solution to remove any residual surface fungal growth, construction debris, settled mould spores.

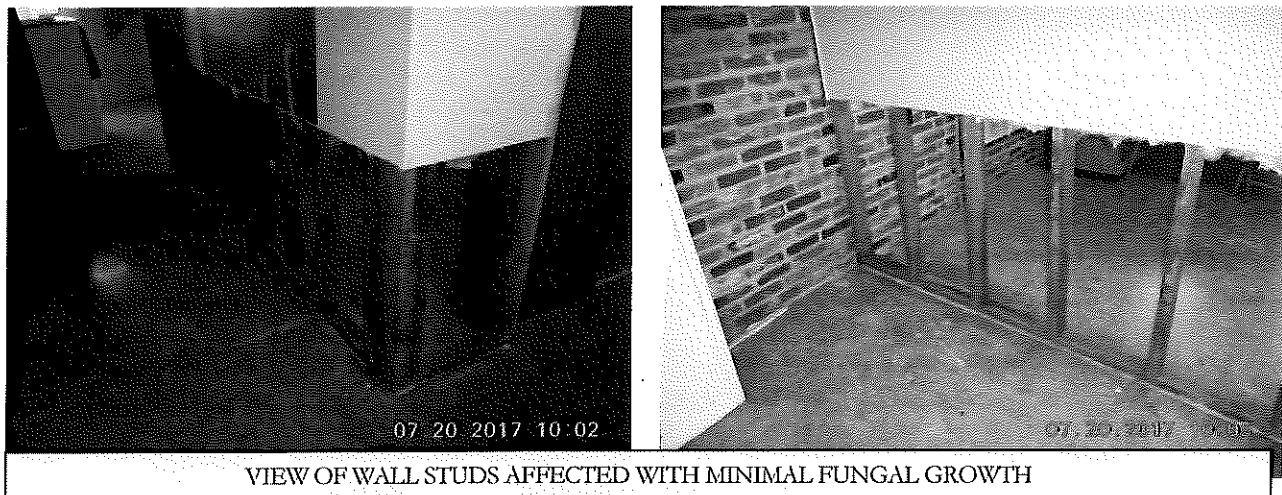
Basement - Fellowship Hall

- During the inspection of the fellowship hall, it was observed that the sheetrock/drywall on walls in the south end to have been removed prior to this inspection.

- The inspection observed surfaces of various exposed wall studs to be affected minimal microbial/fungal growth.
- The inspection of the return air system (located below grade) along the west end of the room to be affected with visible ponding water at the time of the inspection from groundwater.

Therefore, it is recommended that the microbial/fungal growth affecting the walls studs and the bottom plate be cleaned by wet wiping with a TSP, soap & water, or other approved detergent solution to remove any residual surface fungal growth, construction debris, settled mould spores

Area:	Level:	Recommendations:
Basement Fellowship Hall	Small	While utilizing applicable recommended remediation procedures as detailed below in Section 8.0 , a containment is not necessary in order to facilitate the following: 1. Clean walls studs and bottom plate by wet sanding or wiping with a TSP, soap & water, or other approved detergent solution to remove any residual surface fungal growth, construction debris, settled mould spores. 2. A heating and air conditioning contractor should be hired to possibly install a ductwork system within the original below grade system. At the completion of all remediation procedures, surfaces throughout the work area and/or containment should be final cleaned by HEPA vacuuming and/or by wet wiping with a TSP, soap & water, or other approved detergent solution to remove any residual surface fungal growth, construction debris, settled mould spores, etc.

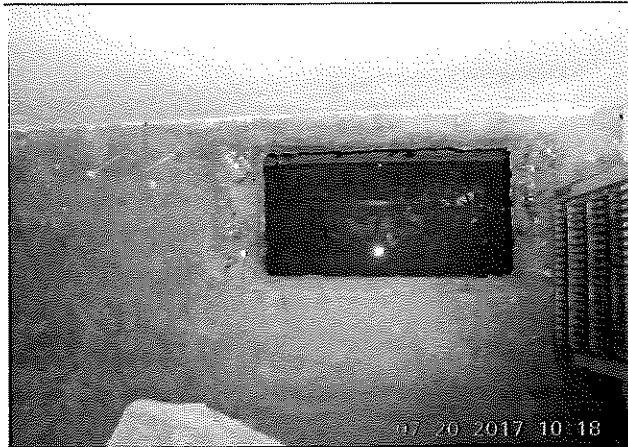
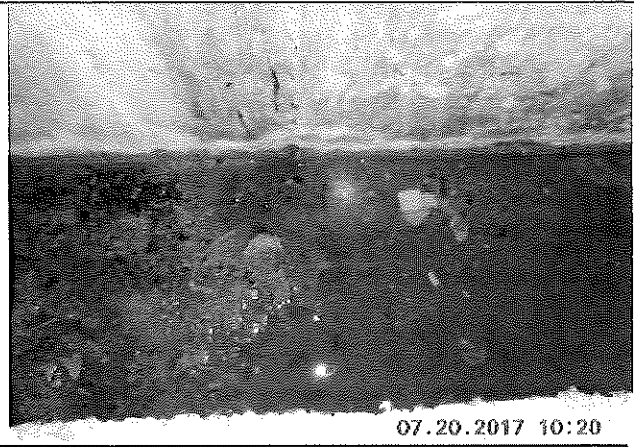
VIEW OF RETURN AIR SYSTEM BELOW GRADE AFFECTED WITH PONDING WATER

The inspection of the fellowship hall located in the basement identified the return air system to be below. As a result, the return air system is repeatedly affected with water intrusion from groundwater. The ponding water in the return air system as the high potential elevating the relative humidity within the living space above the ASHRAE Standard 55 of 30% to 50%. Relative humidity levels above 60% have been documented to produce environments ideal for the proliferation of fungi on surfaces. It is my belief that the musty odors observed in the fellowship hall are most likely generated from the ponding water within the return air system.

Therefore, it is recommended to in my professional to improve the indoor air quality, that the current below grade return air system be abandoned. It is my belief that rerouting the return air system appears to be not an achievable retrofit. It is recommended that a heating and air conditioning contractor be hired to possibly install a ductwork system within the original below grade system.

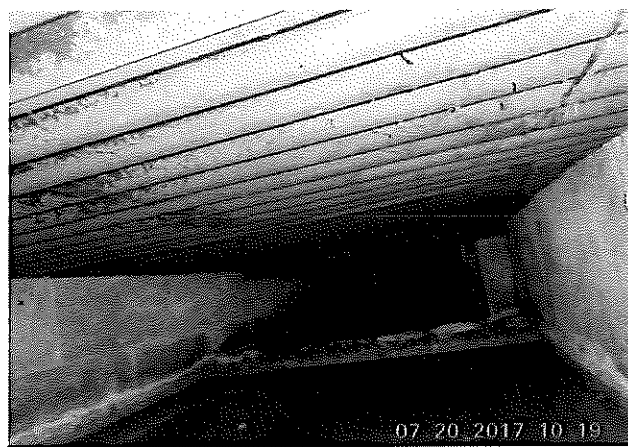
VIEW OF RETURN AIR SYSTEM AFFECTED WITH PONDING WATER

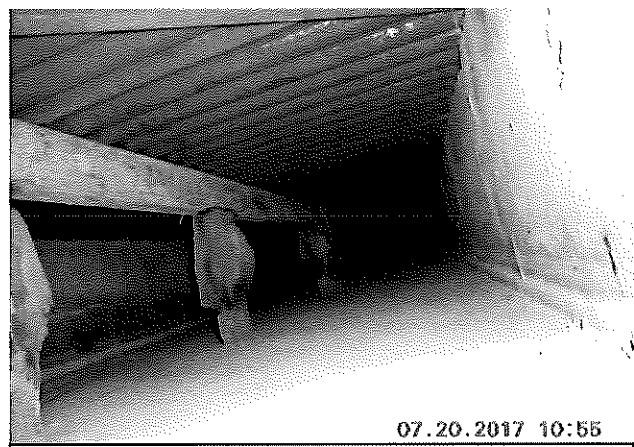
- Located within the return air system towards the south end are wood framing to most likely installed in order to support the concrete floor during installation of the concrete for the floor. The wood framing was observed to be affected with visible wood decay fungi and microbial/fungal growth due repeated exposure to water.

VIEW OF FUNGAL GROWTH AND WOOD ROT ON WOOD SUPPORTS WITHIN THE RETURN AIR SYSTEM
