Scope of Work

Inspection of Property: 802 N. State St. Augusta, KS 67010

In re: Condition of Foundation Survey

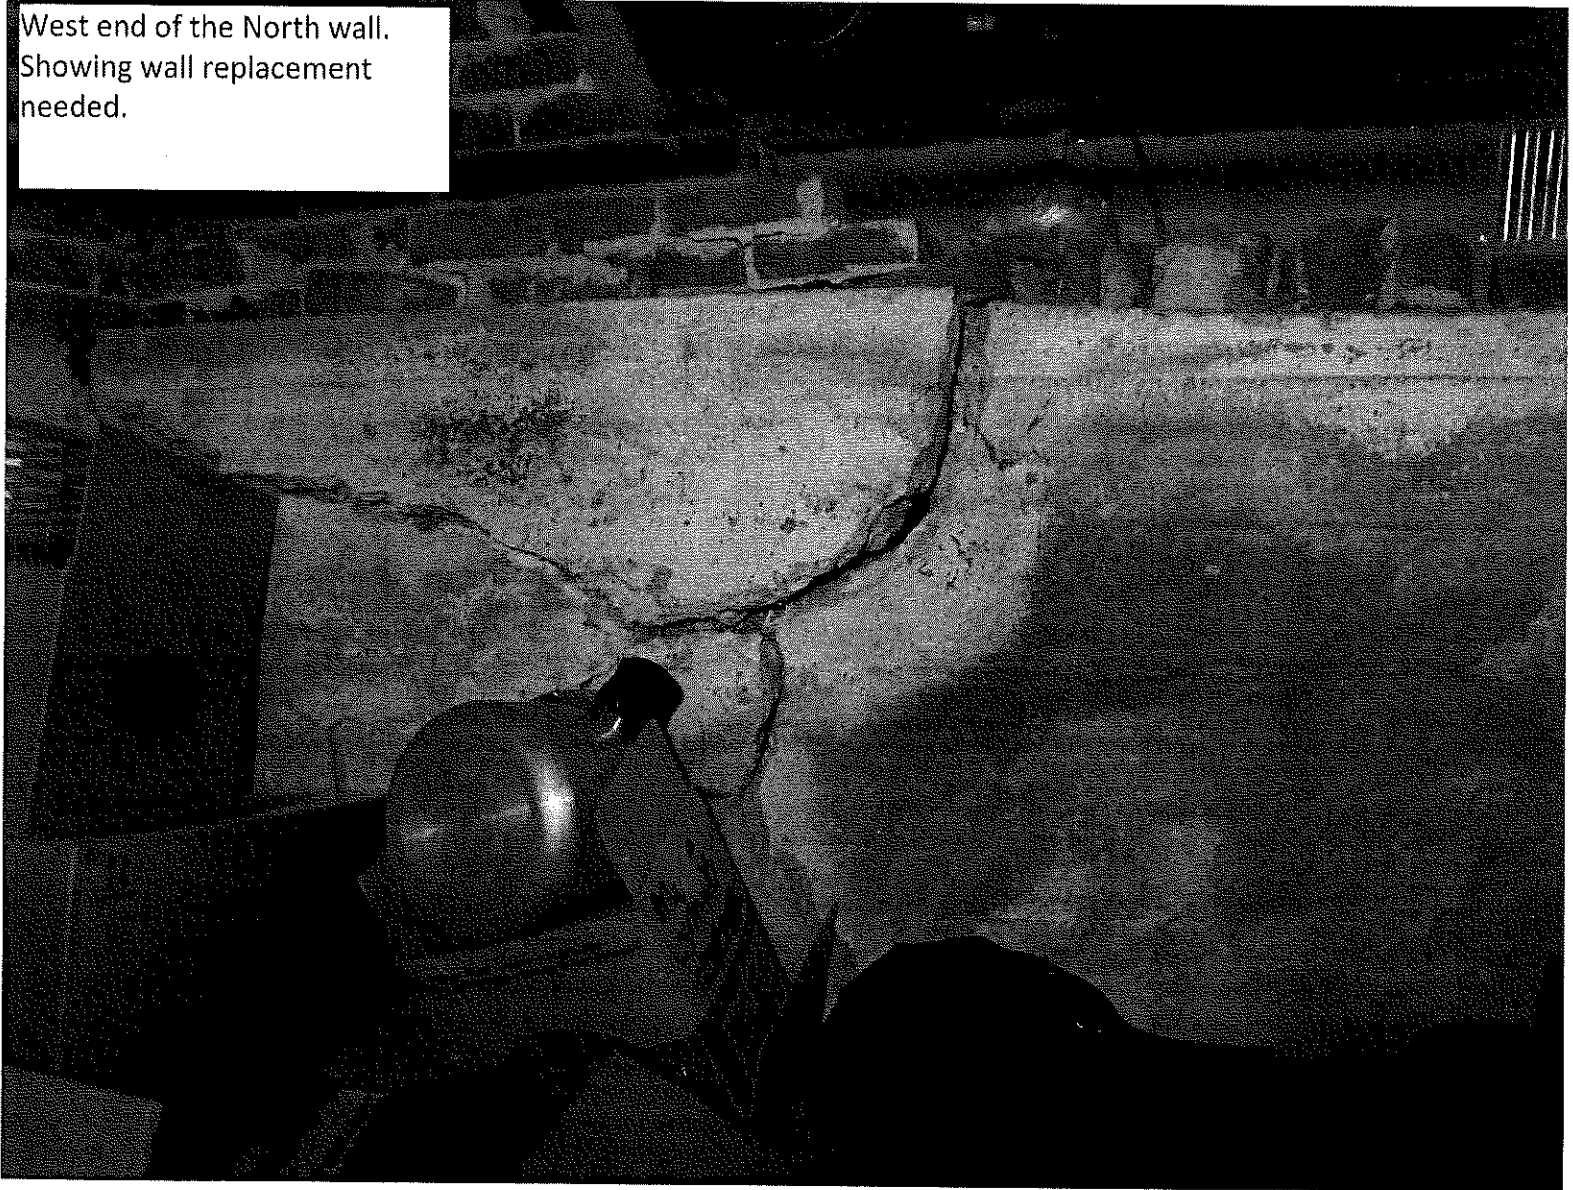
The North basement wall is 20' in length and shows lateral movement. The West area of the wall is in need of replacement. (See pictures).

West end of the North wall.
Showing wall replacement
needed.

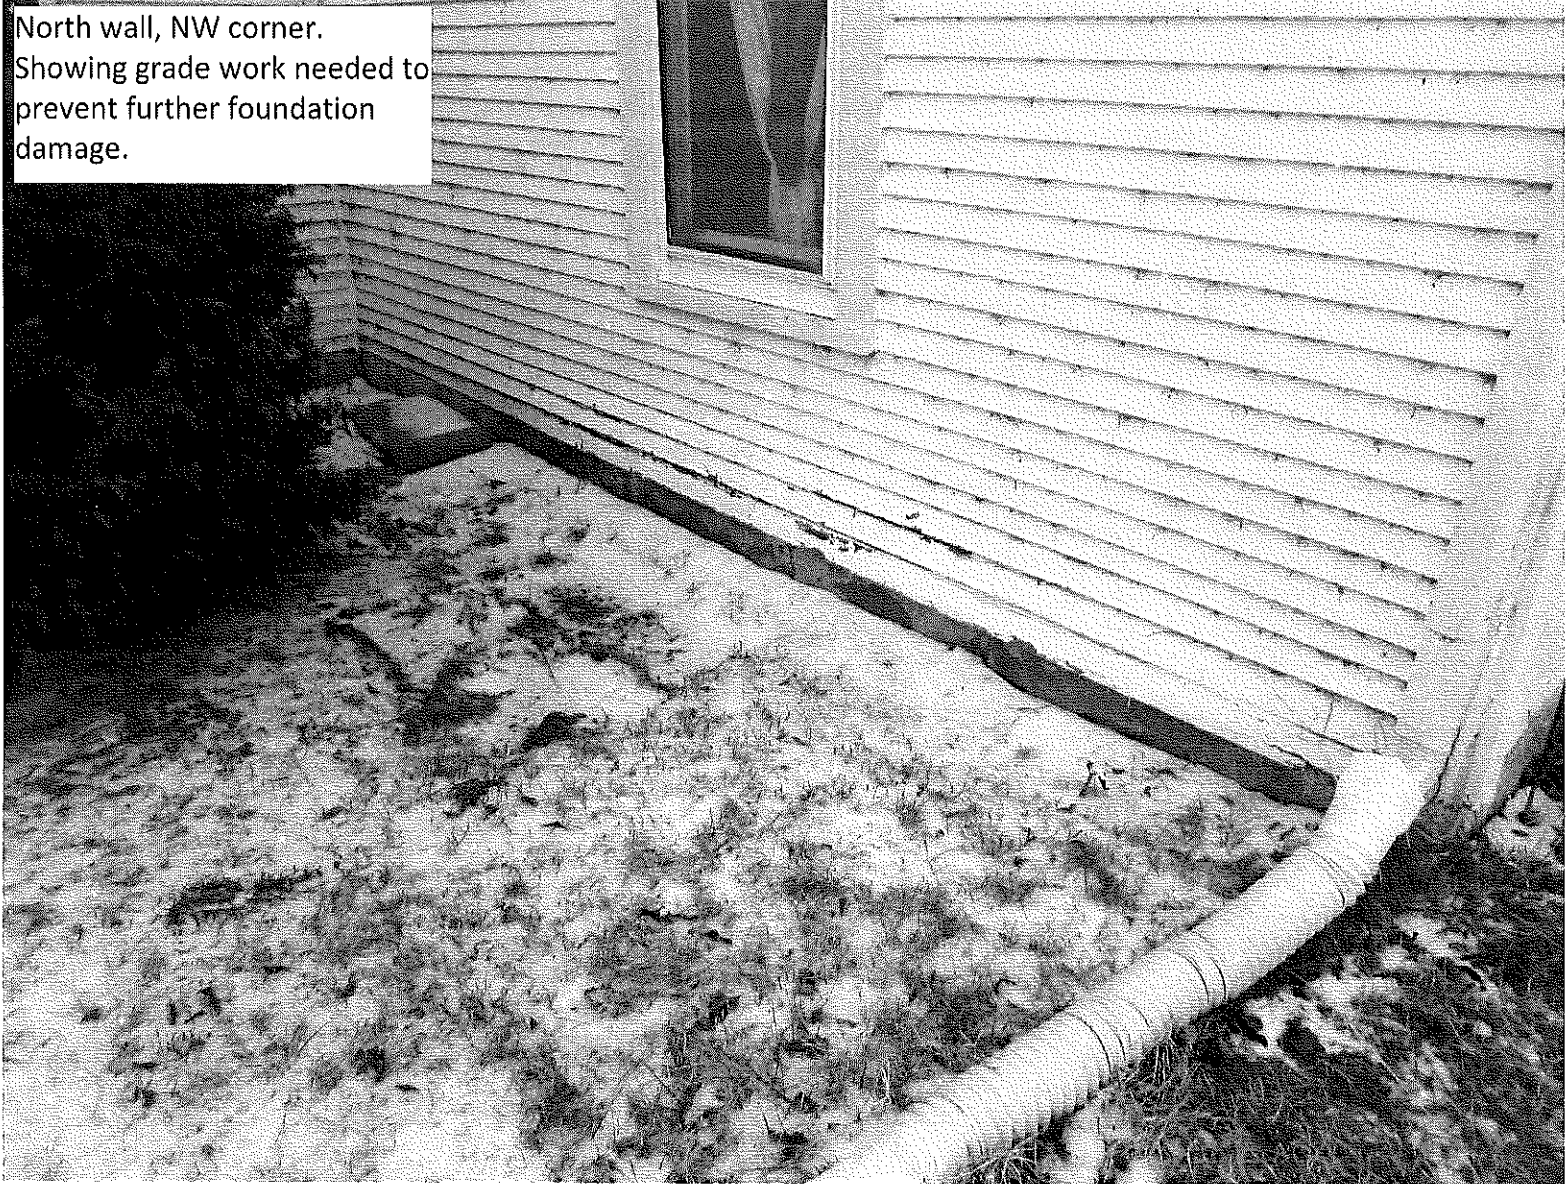
The perimeter drainage around the property appeared to be in need of improvement. It was not raining at the time of the inspection, and therefore, it could not be determined with certainty if water would pool at any localized low areas around the property.

North wall, NW corner.
Showing grade work needed to
prevent further foundation
damage.

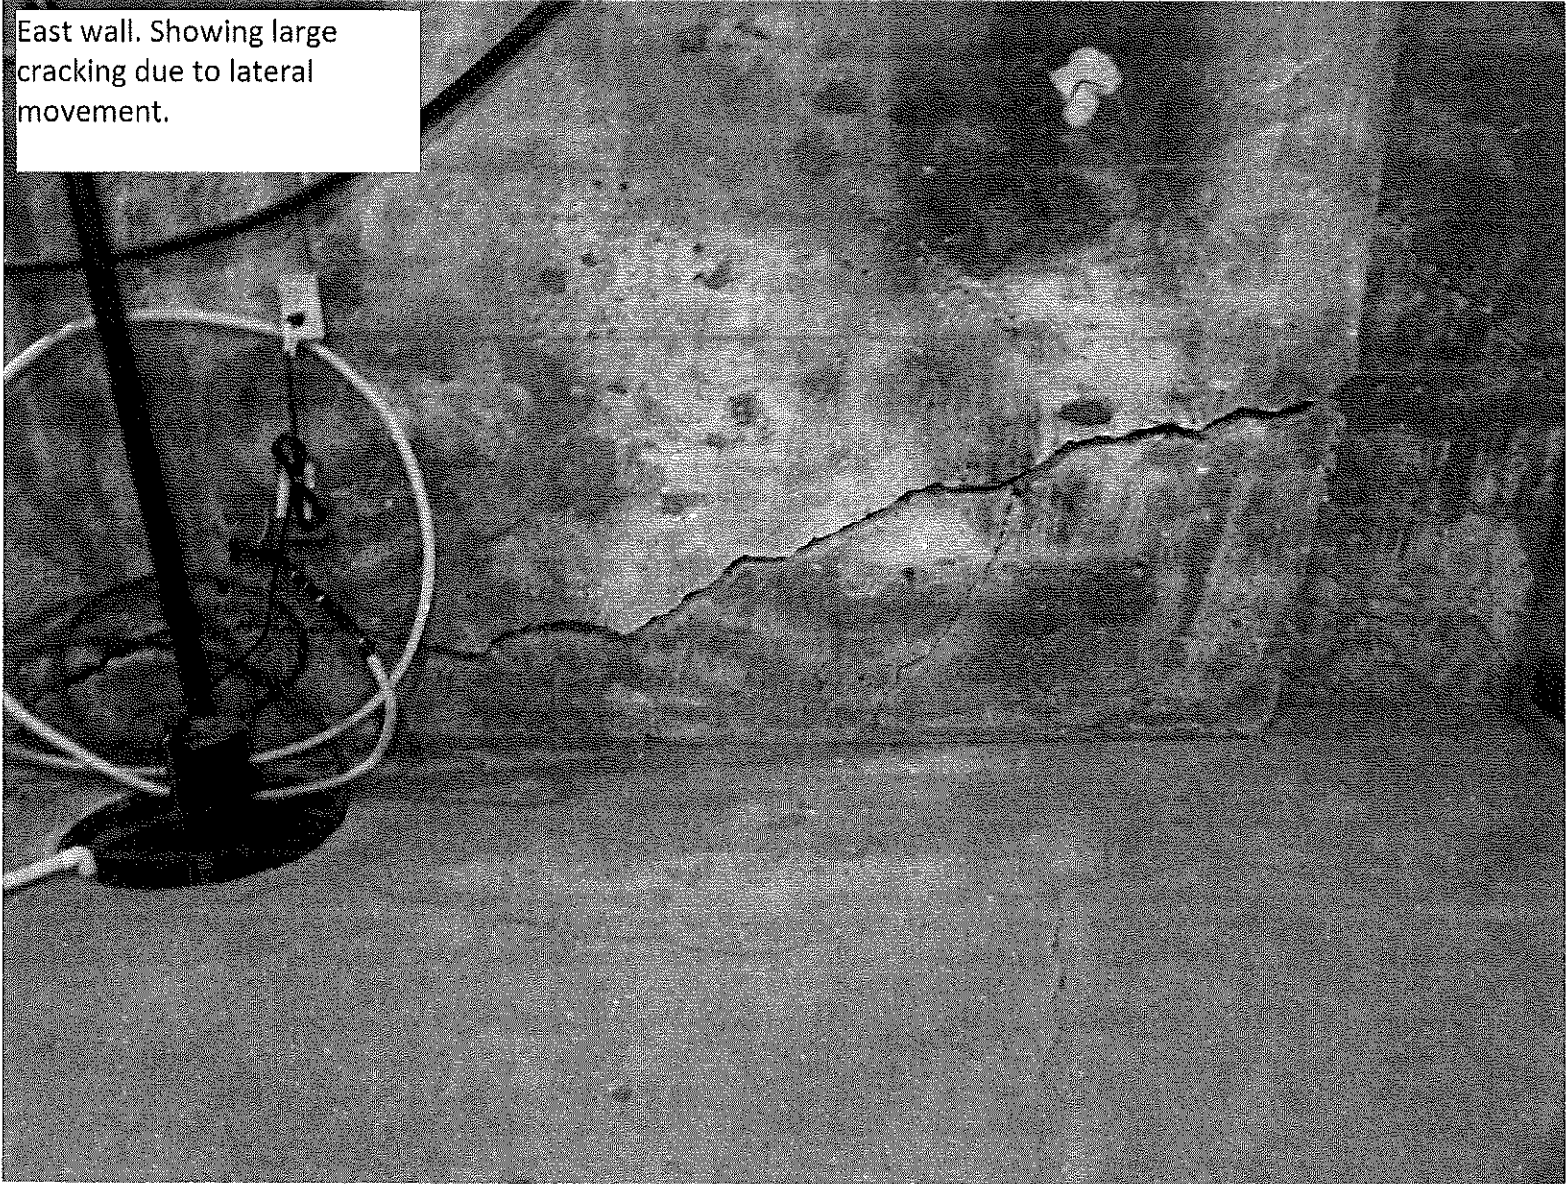
The East basement wall is 20' in length and shows 3-1/4" lateral movement. There are large visible cracks on the interior. The proper repair is the installation of 4 wall anchors.

East wall. Showing large cracking due to lateral movement.

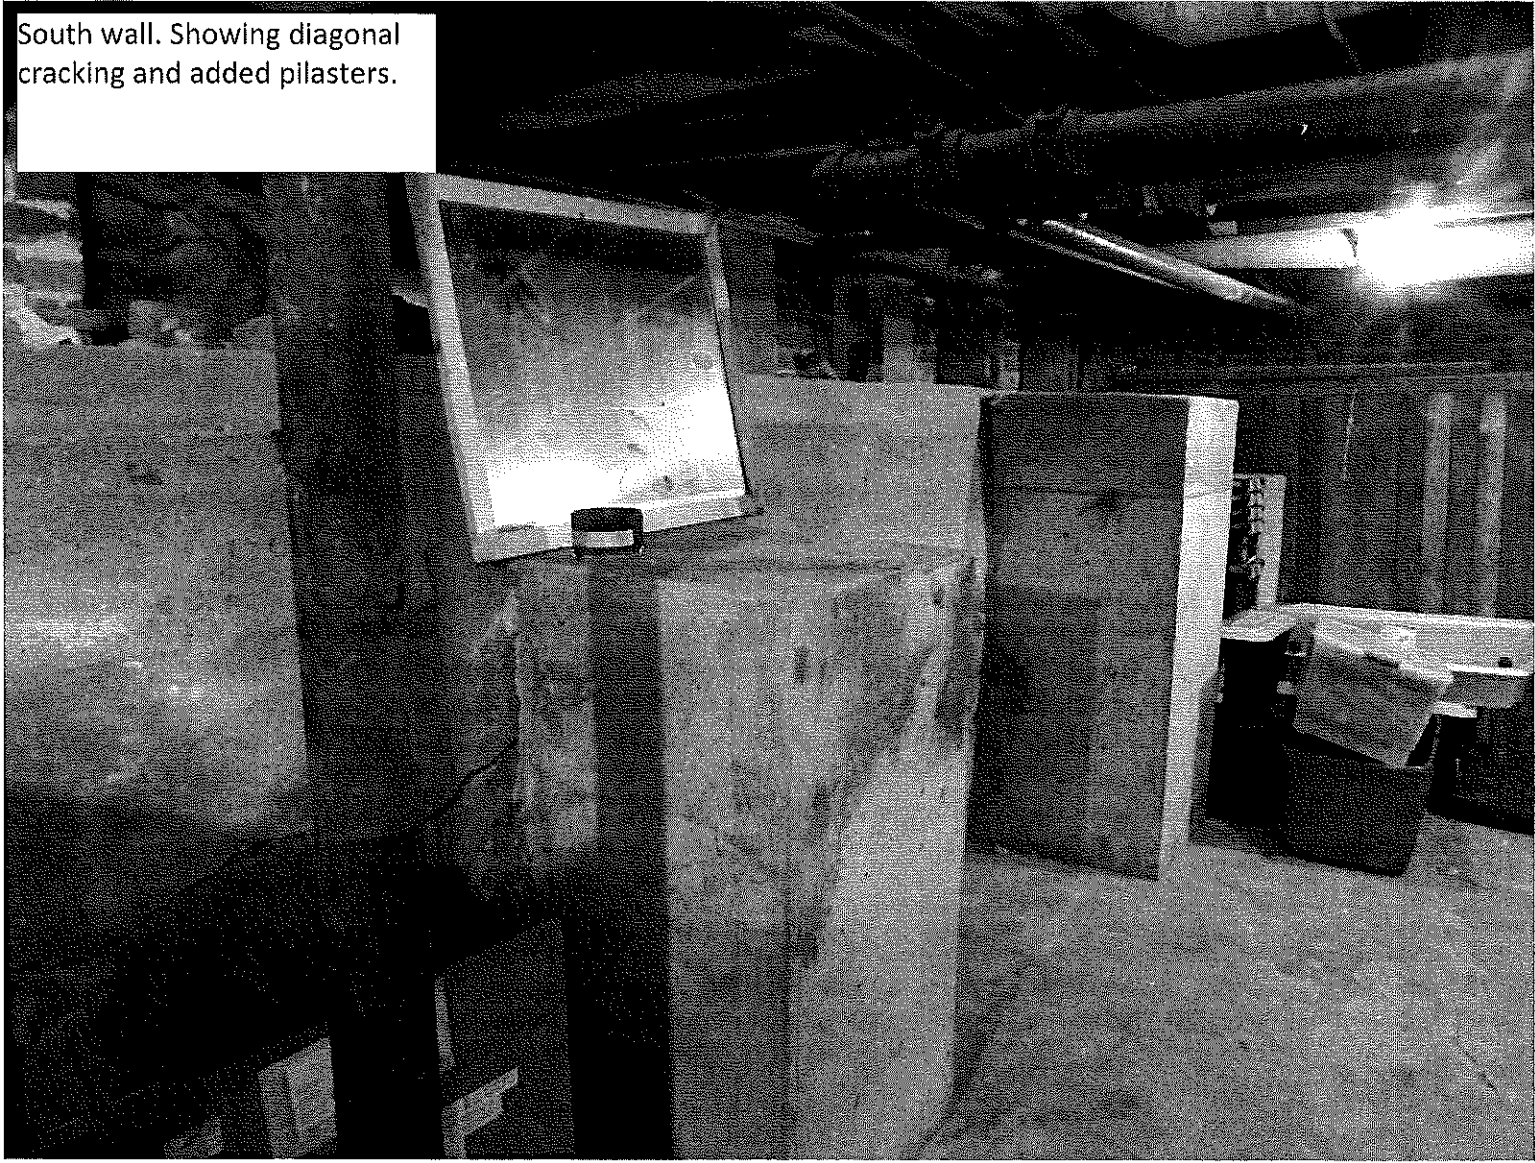
The South basement wall is 35' in length and shows 2 1/2" lateral movement. There is horizontal cracking along the entire wall, and 4 added pilasters. The wall has had additional movement since the pilasters have been added, and is in need of proper supports. The proper repair is the installation of 8 wall anchors.

South wall. Showing diagonal cracking and added pilasters.

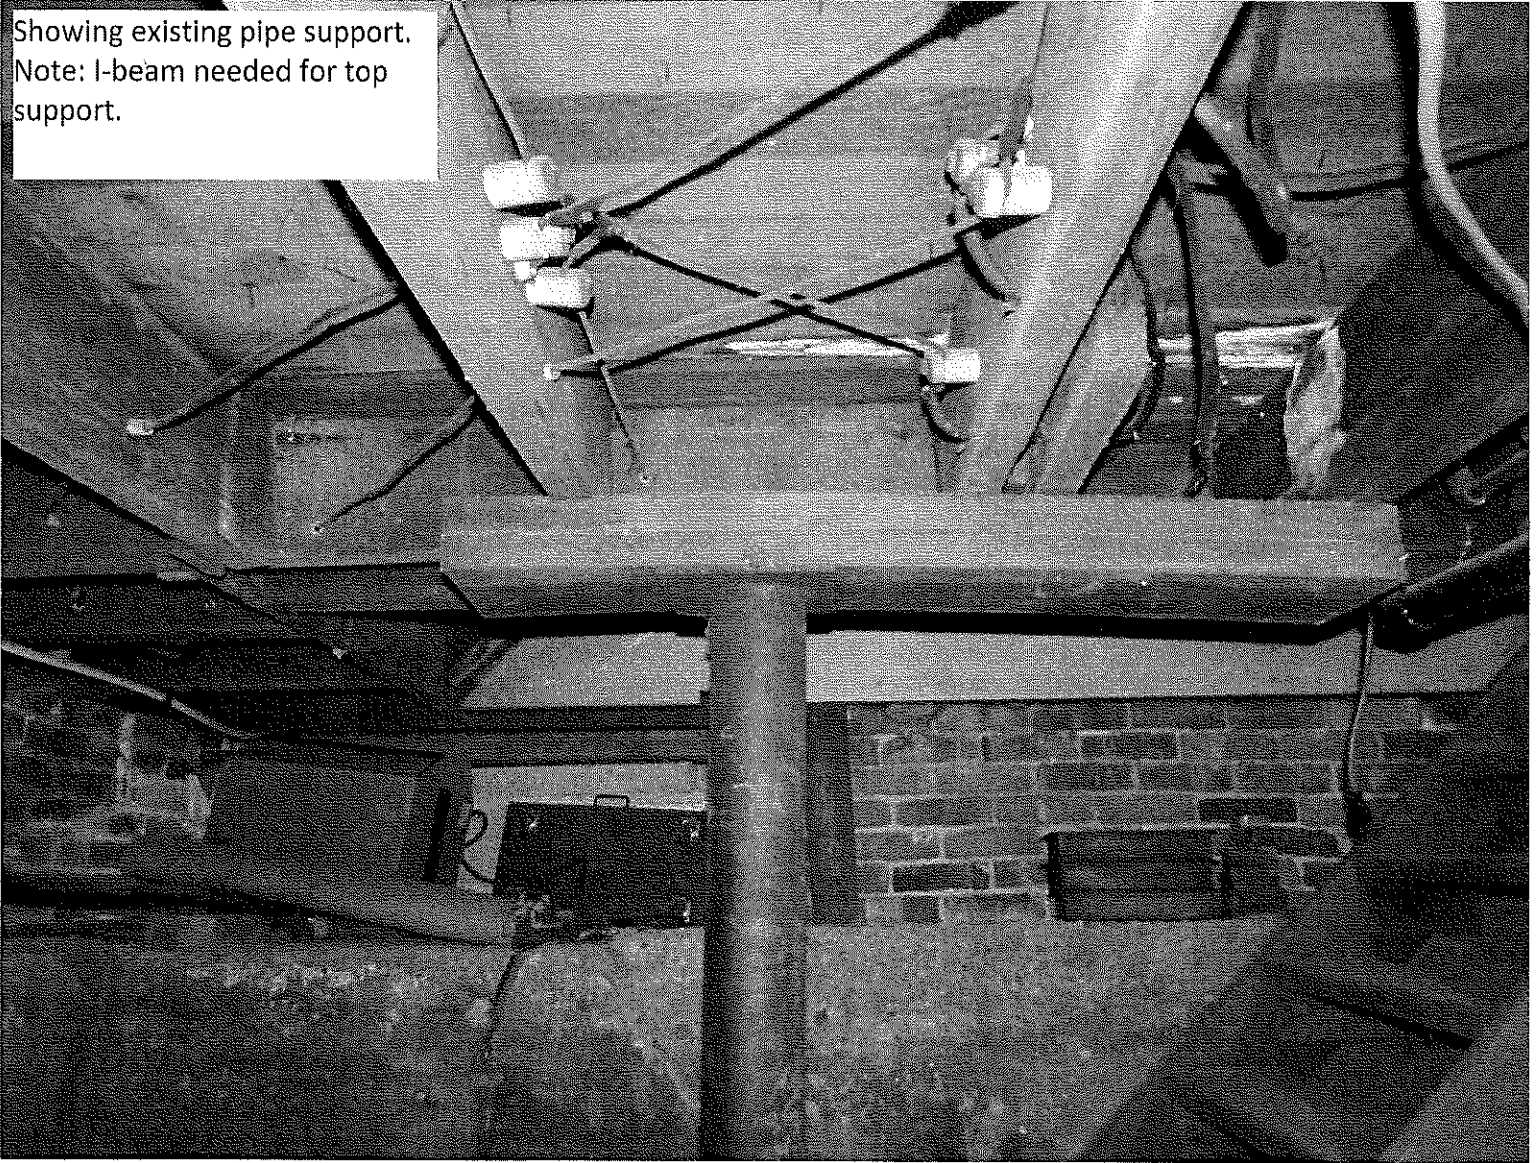
Showing existing pipe support.
Note: I-beam needed for top support.

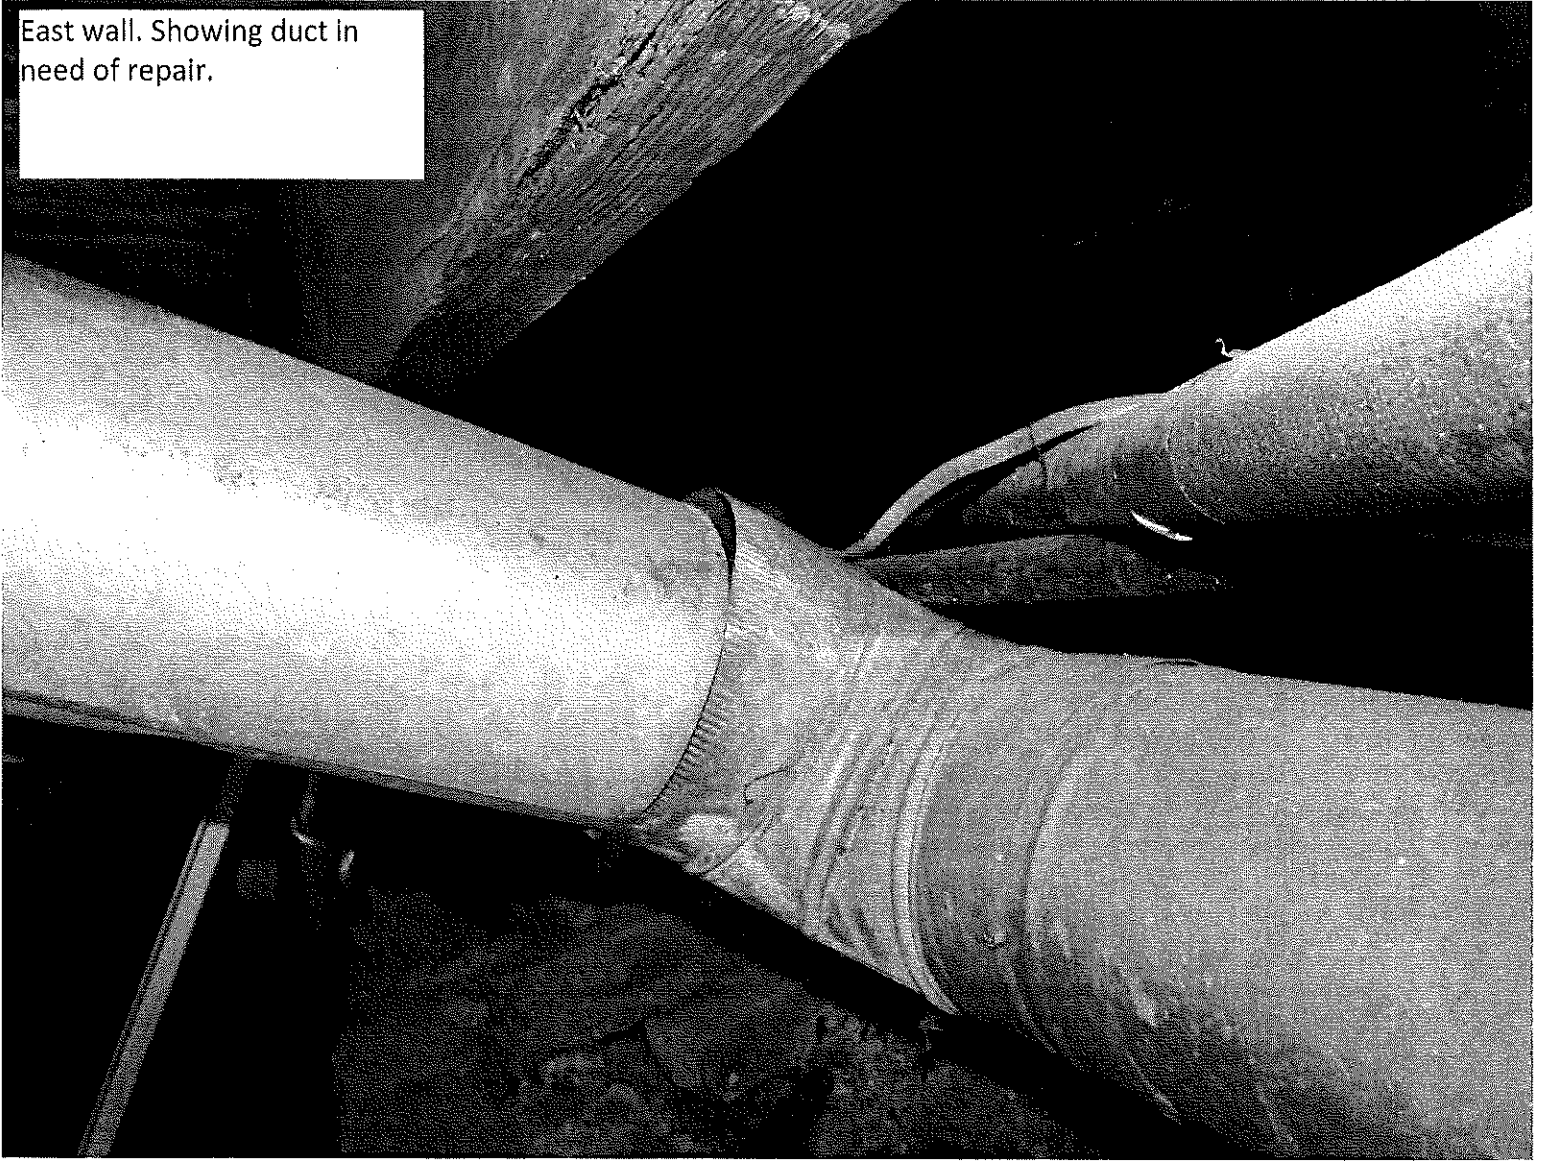
East wall. Showing duct in need of repair.

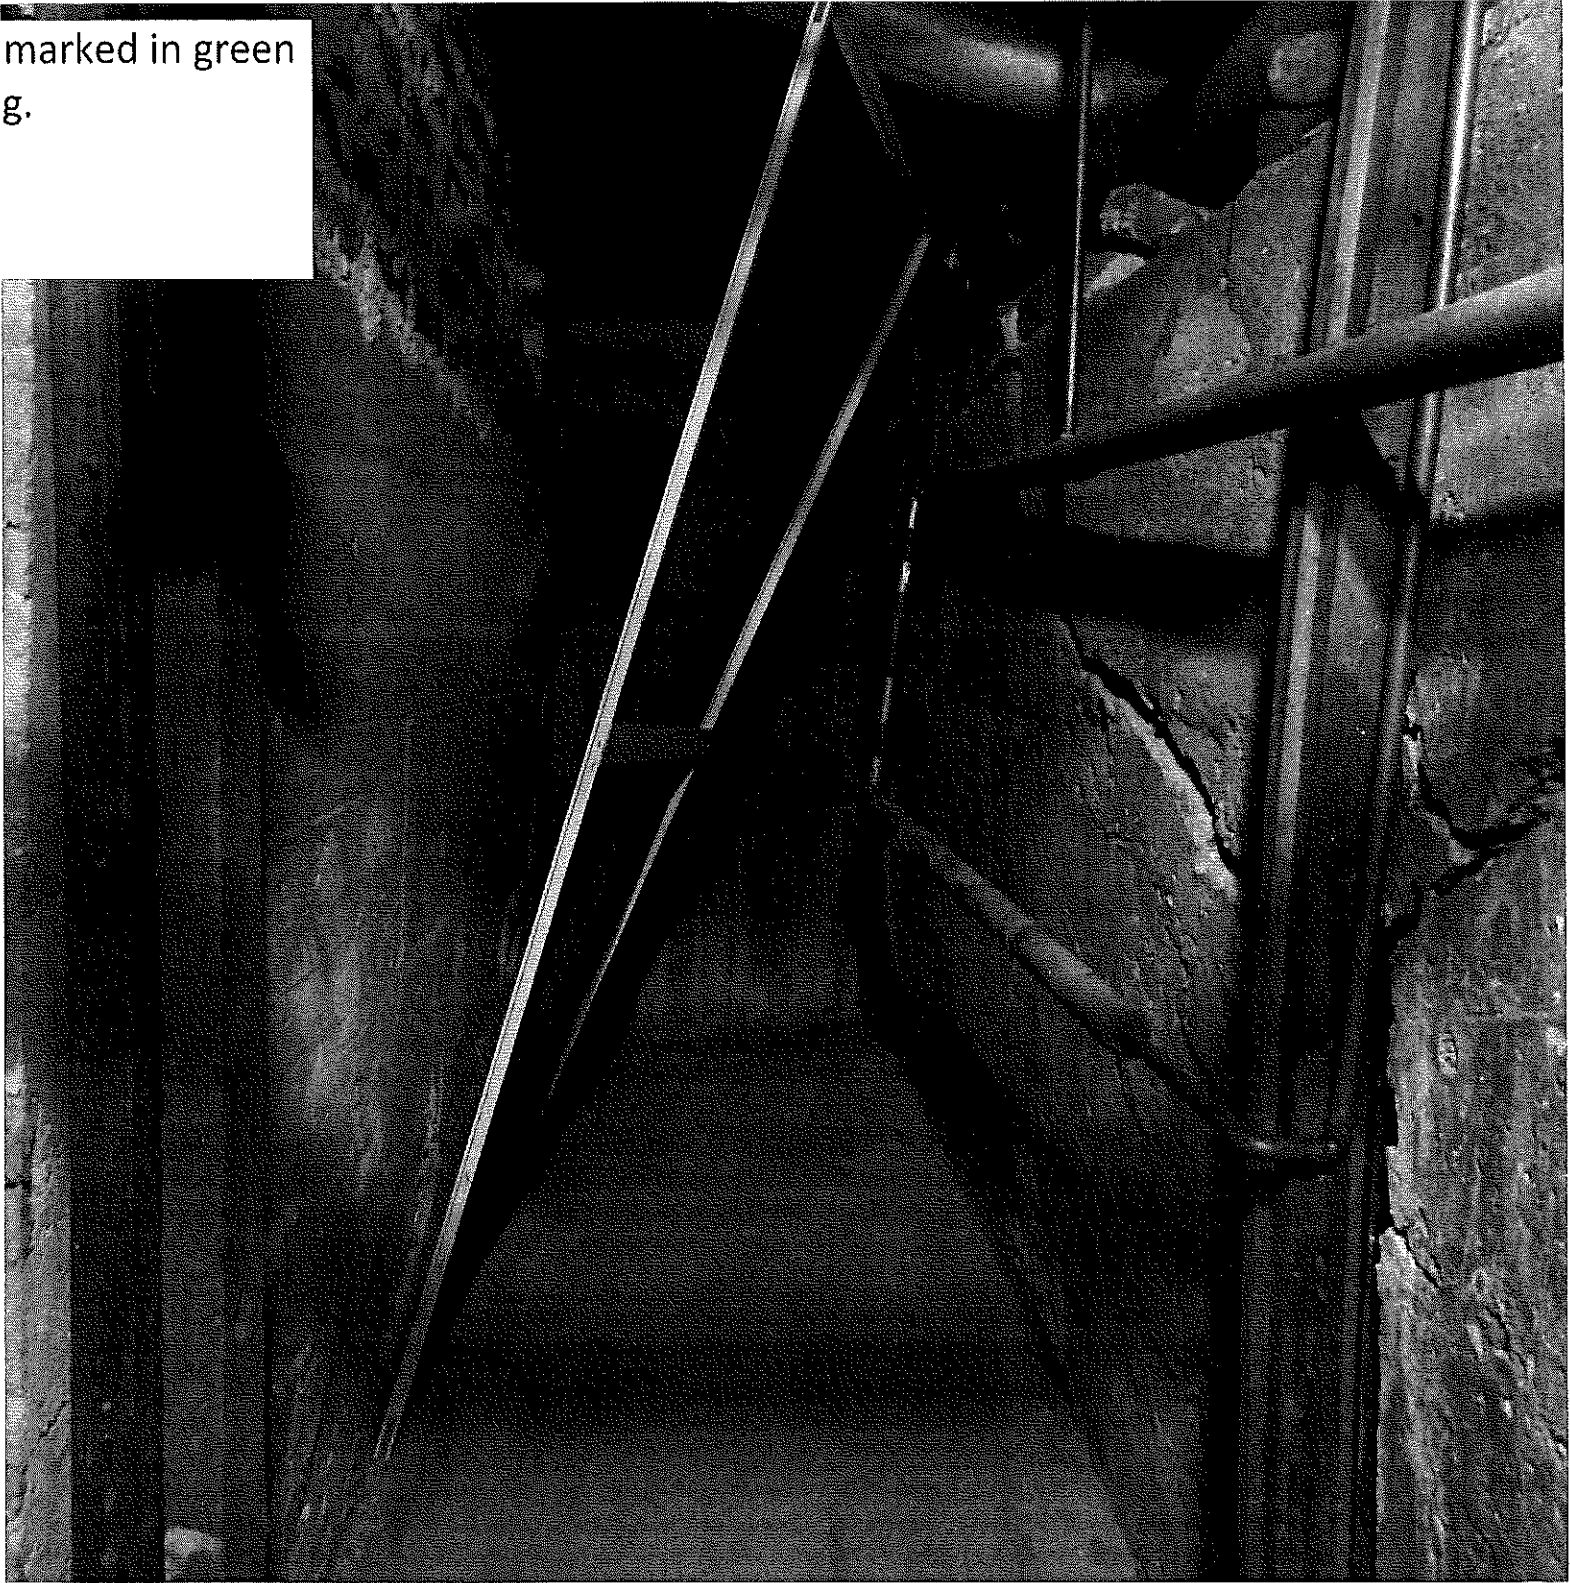
marked in green
g.

- I do not recommend the installation of steel beams with added top bracing. The floor system will not support the added lateral pressure
- The area marked in green on the drawing is in need of added bracing with cross bracing. Note: These beams will not be attached to the floor system
- The home would benefit with the installation of downspout extensions

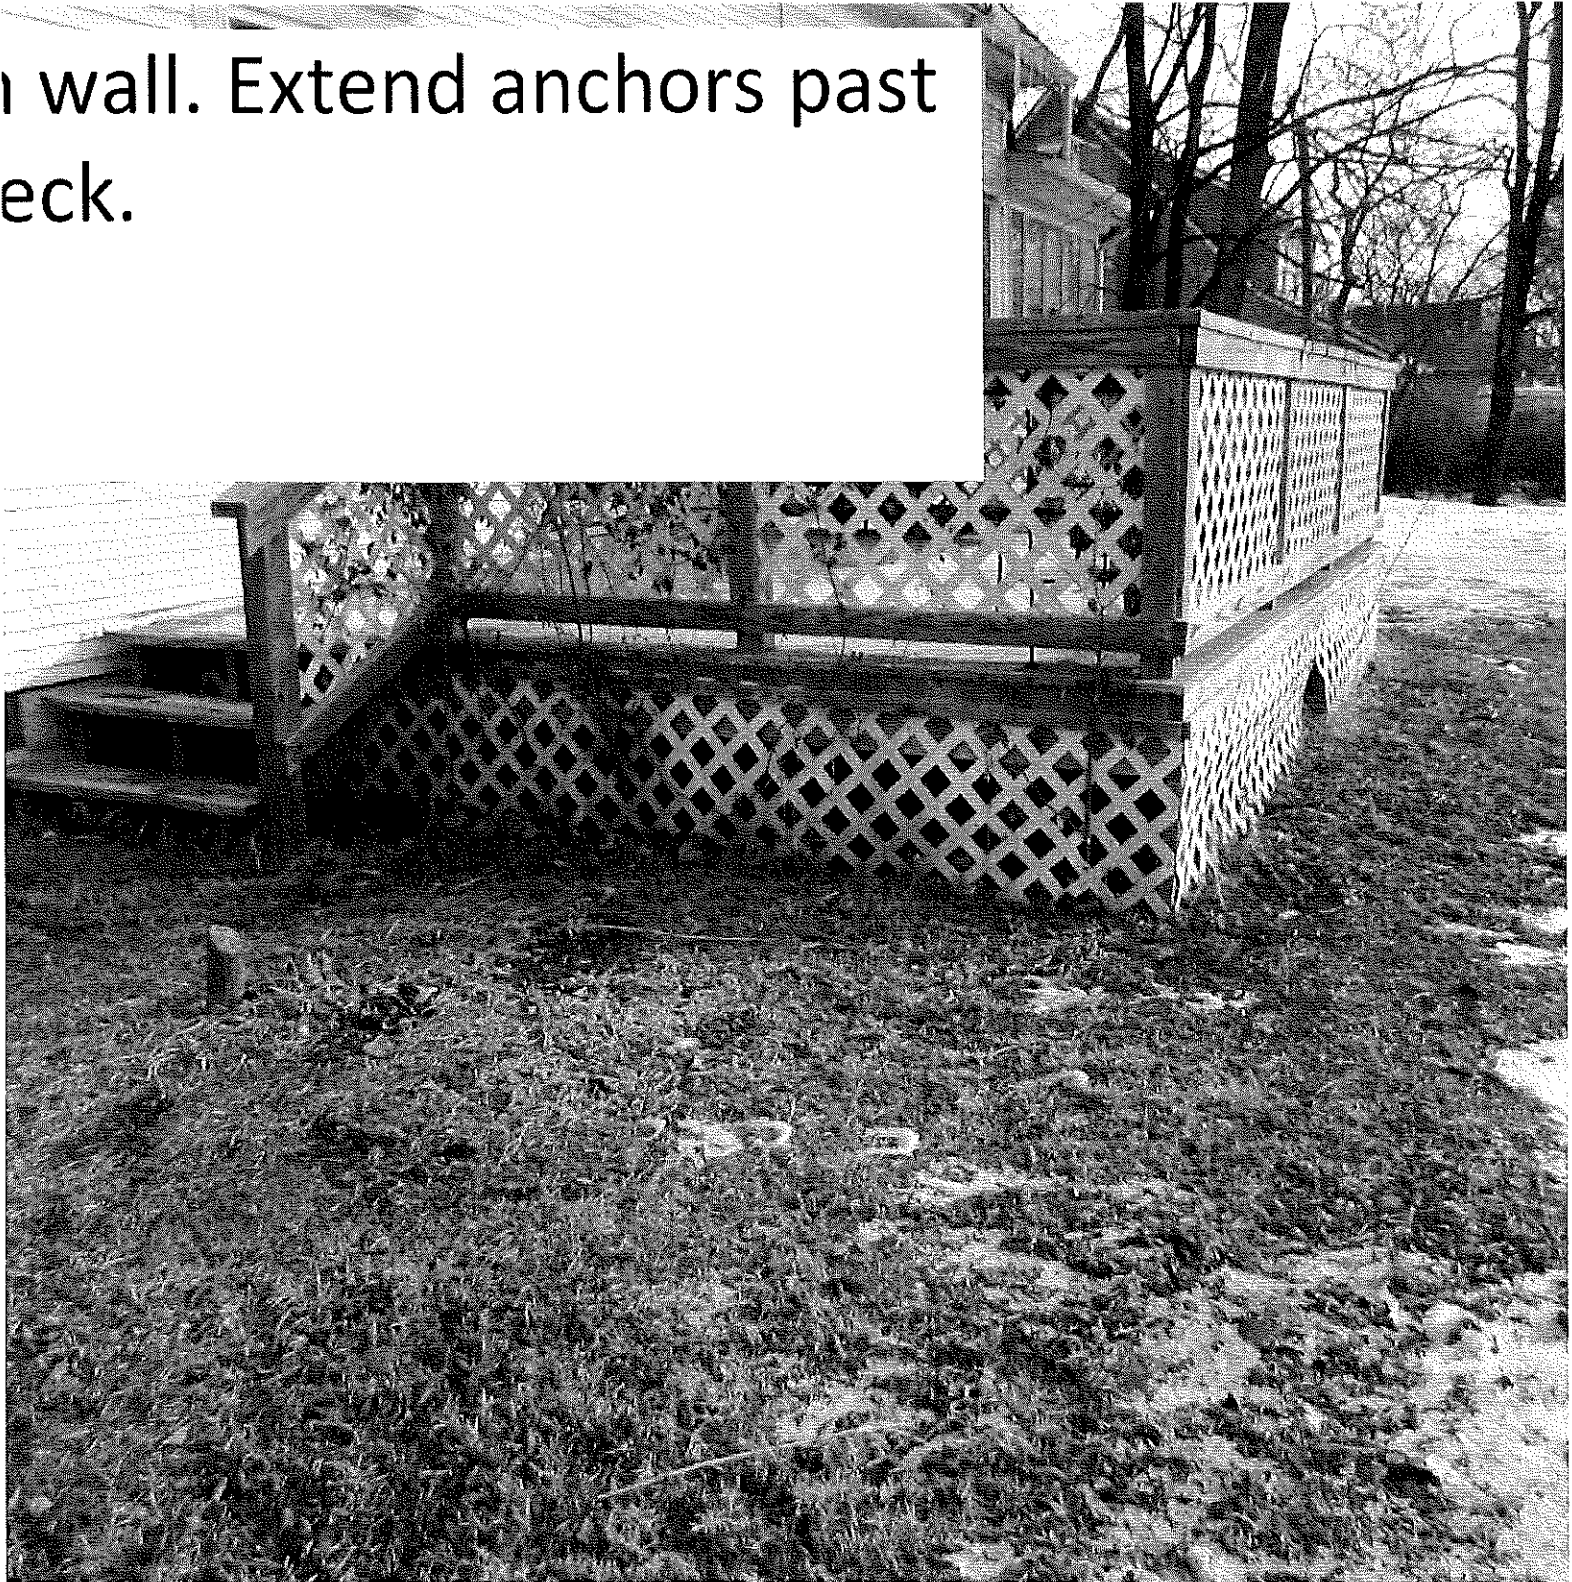
1 wall. Extend anchors past
eck.

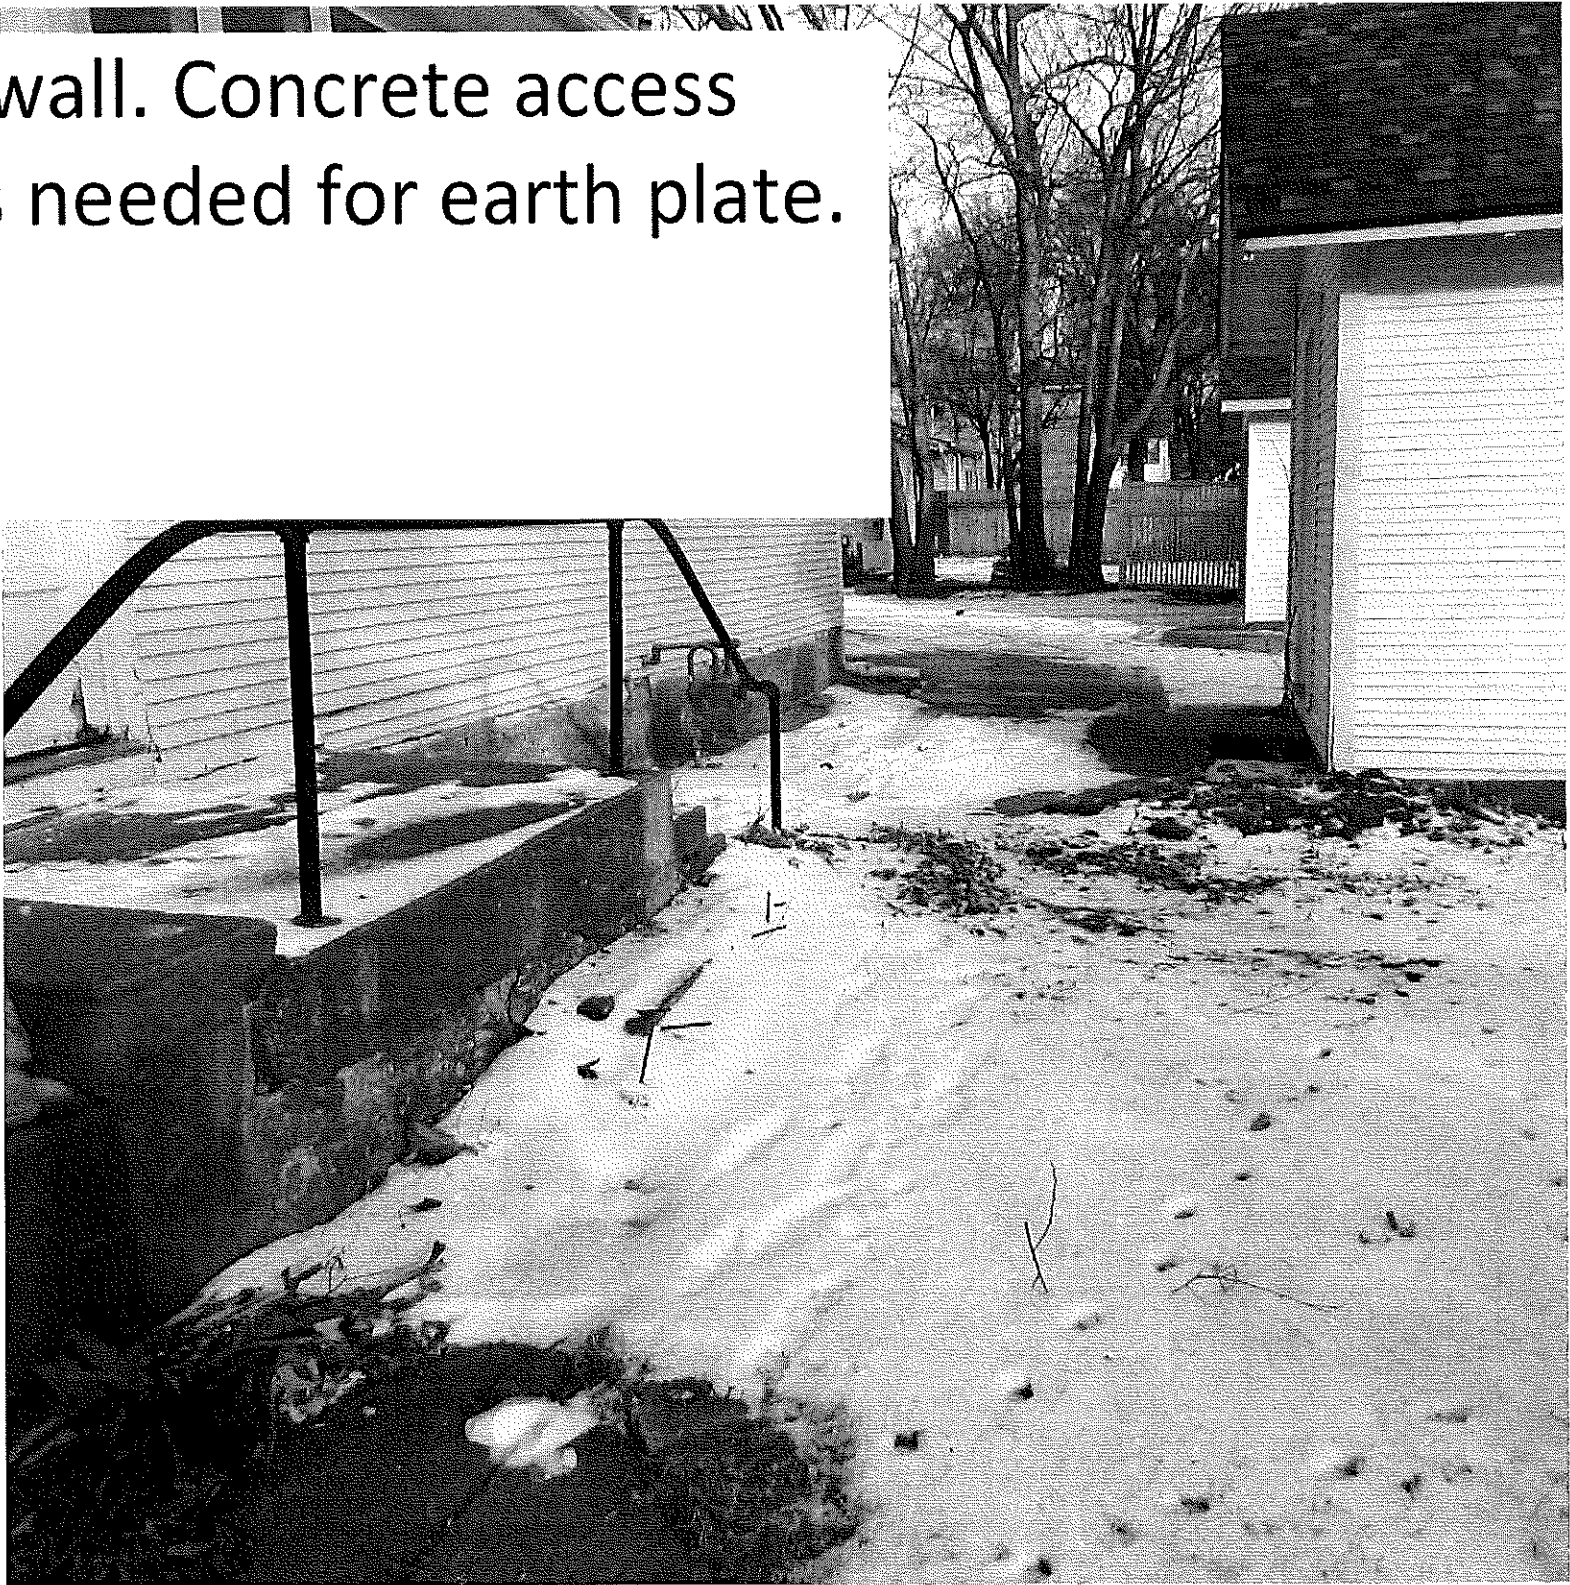
wall. Concrete access
needed for earth plate.
