Scope of Work

Inspection of Property: 802 N. State St. Augusta, KS 67010

In re: Condition of Foundation Survey

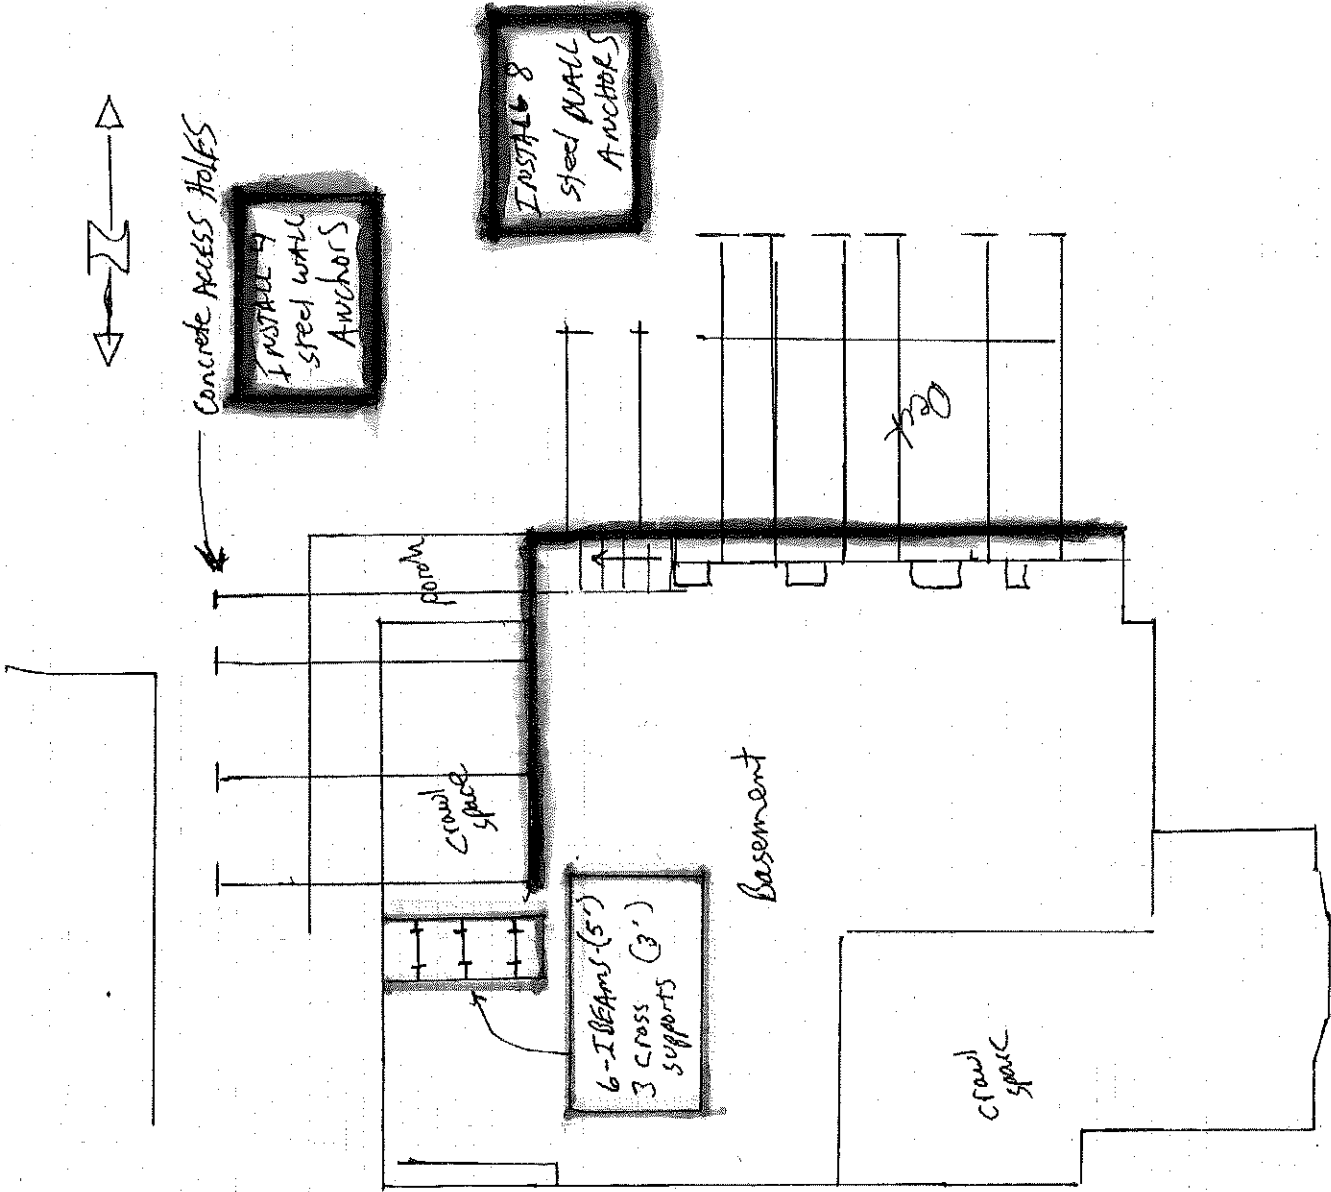
Area marked in red on the drawing.

Area marked in green on the drawing.

Install 12 wall anchors.

Install 6 steel I-beams. (5')

Install 3 cross beams. (3')
